FERC AFTER ACTION PANEL

ASSESSMENT OF OROVILLE SPILLWAY

INCIDENT CAUSES AND

November 23, 2018

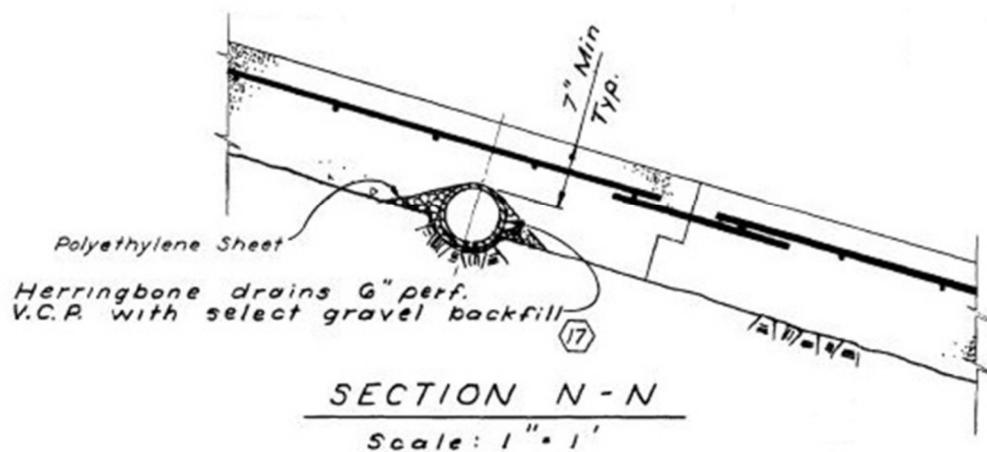
**Fig. 2.2.1 Herring-Bone Drain Encroaching in the Chute Slab.**

- Underdrains intruding into the chute slab section, reducing the thickness of concrete above the drains to 7 inches or less (compared to a design minimum slab thickness of 15 inches elsewhere). This condition resulted in cracks above most of the herringbone drains. The cracks allowed water to pass through the slab and also led to a propensity for concrete delamination and spalling in the slab.*

The herringbone drainpipe system encroaching into the thin chute slab, Fig. 2.2.1, induced a reflective pattern of vertical cracks above the herringbone drains all along the slab that were first observed within a month of concrete placement and were clearly visible since the early days of operation. The crack pattern formed by these drains (blue line emphasis) as seen from the air, is shown in Fig. 2.2.2.

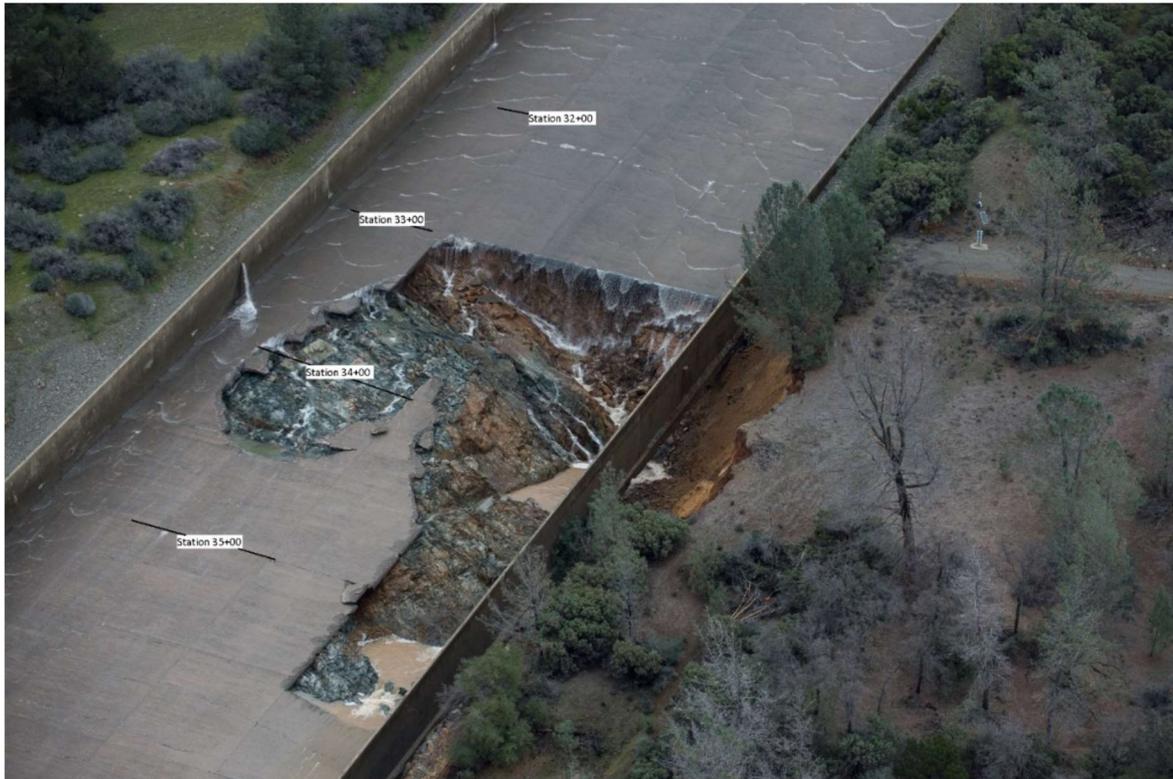
**Fig. 2.2.3 Initial Erosion Visible on February 8, 2017.**

The second category of the physical factors identified in the IFT Report was “poor spillway foundation”, as illustrated in Fig. 2.2.3, where the initial erosion occurred at about chute Sta. 33+00. Existing original construction records contain numerous references to soil like materials that were found to be present in this area. Project specifications indicated that when such materials were encountered they should be excavated out until a competent rock foundation was located and backfilled to grade with concrete. The Contractor encountered, erodible, soil like materials in the area of Sta. 33+00 and estimated the cost to satisfy the specification requirements (reference). The field decision

to install the chute over compacted soil like materials has been clearly implicated in the failure of the chute slab.

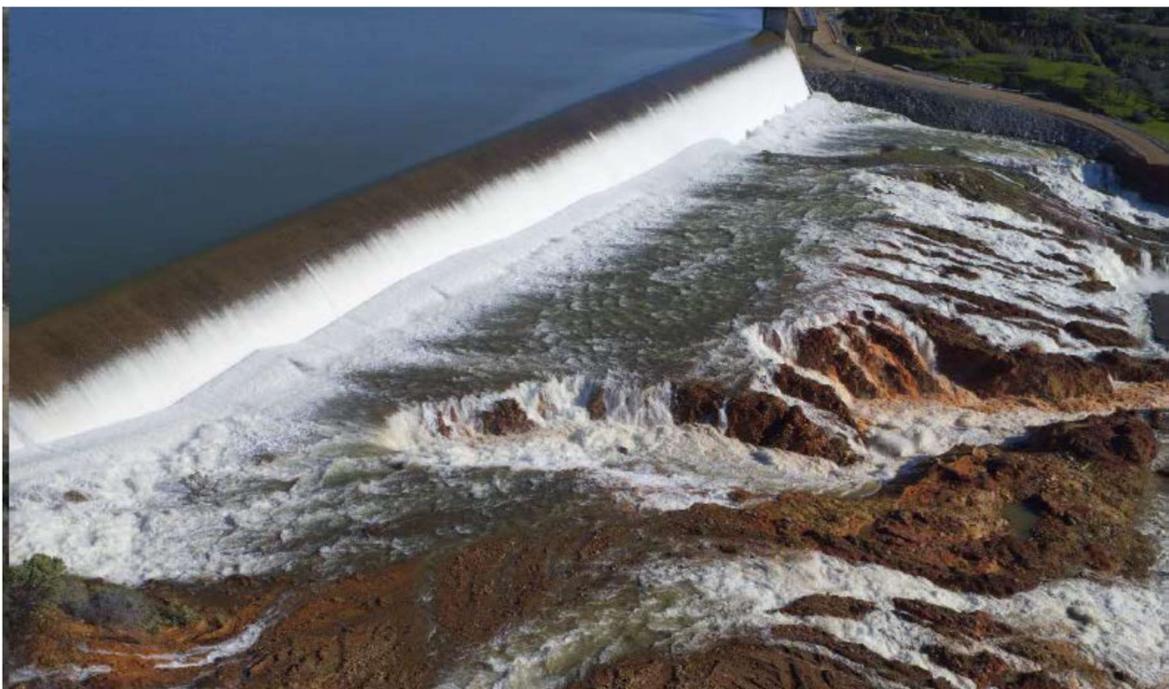
**Fig. 2.2.4 (IFT, p. 39)**

Bracketed numerals, [24], as cited above refer to the numbered reference cited within the IFT Report. In Fig. 2.2.4 the erosion is shown on the downstream side of the Emergency Spillway which occurred from February 11 to February 12, 2017 from only 1.6 ft. overtopping of the Emergency Spillway Weir.

Figure 4-10: Emergency spillway head cutting on February 12 (from DWR)

*“The principal physical factor contributing to the damage at the emergency spillway was clearly the presence of significant depths of erodible soil and rock in features orientated to allowed rapid headcutting toward the crest control structure. The erodible materials appear to be associated with geologic features such as shear zones. Other factors that contributed to the damage at the emergency spillway include:*

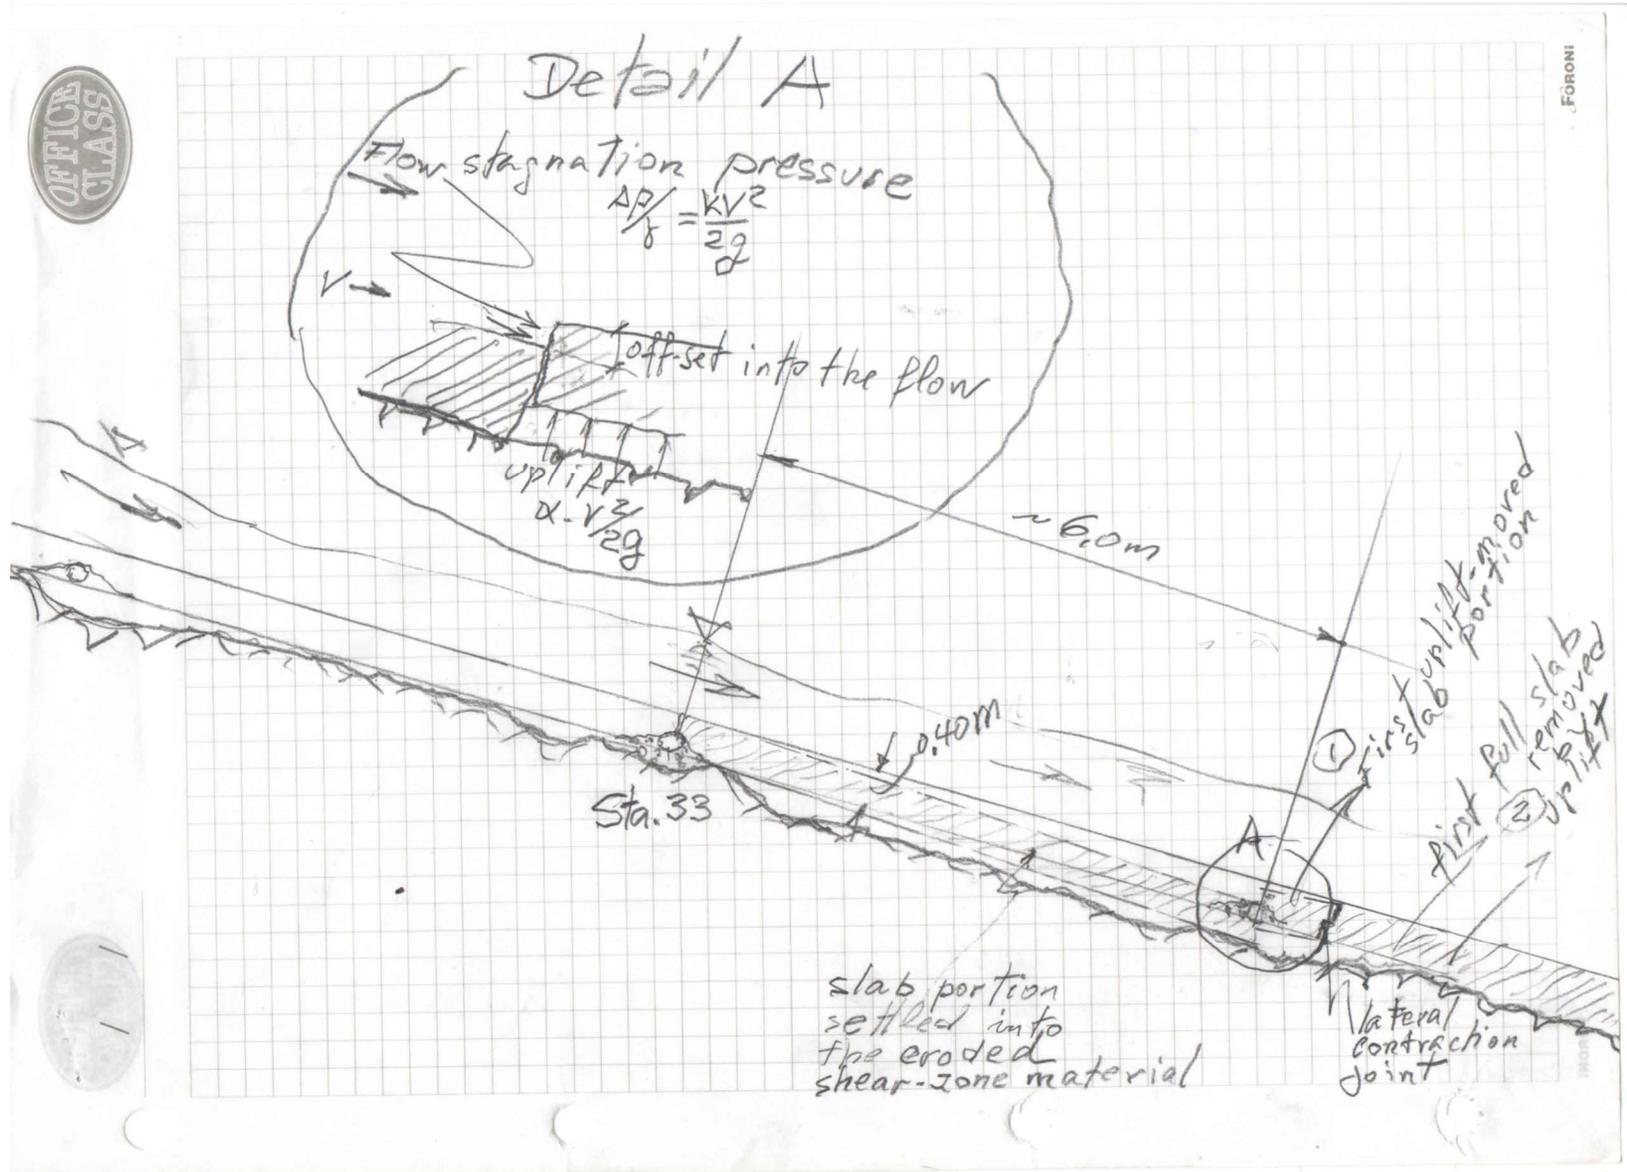
Fig. 2.3.1 Possible Slab Settlement and Resulting Offset Into Flow

The soil erosion was caused by water infiltration during spillway operation, and precipitation events that flowed through the vertical slab cracks that developed above the herringbone drain system as shown by the blue line pattern in Fig. 2.2.2. Discharge from the crack infiltration flow was manifested in the outlet holes along both spillway walls. From the very first time the spillway was operated, these flows were called to the attention of operators and engineers because of the relatively high flow volumes, clearly larger than those anticipated from reservoir seepage. These infiltration water flows gradually eroded the highly weathered materials into the drainpipe system. The slow process passed undetected in the inspections, as no visible indications of slab movements had been observed. However, the slab cracks tended to widen with time and regular repair and maintenance was being performed on an on-going basis. Hence, the rate of erosion, although slow and unnoticed for 50 years, ended up by undermining the concrete slab, at the weaker highly weathered soil foundations in the chute zone, downstream of Sta. 33+00, enough to produce a slab settlement, possibly of only a few inches, on February 7, 2017, as hypothesized in Fig. 2.3.1. Due to the slow progress of the erosion and lack of a visible slab movement until then, the phenomenon remained unnoticed until that critical date.

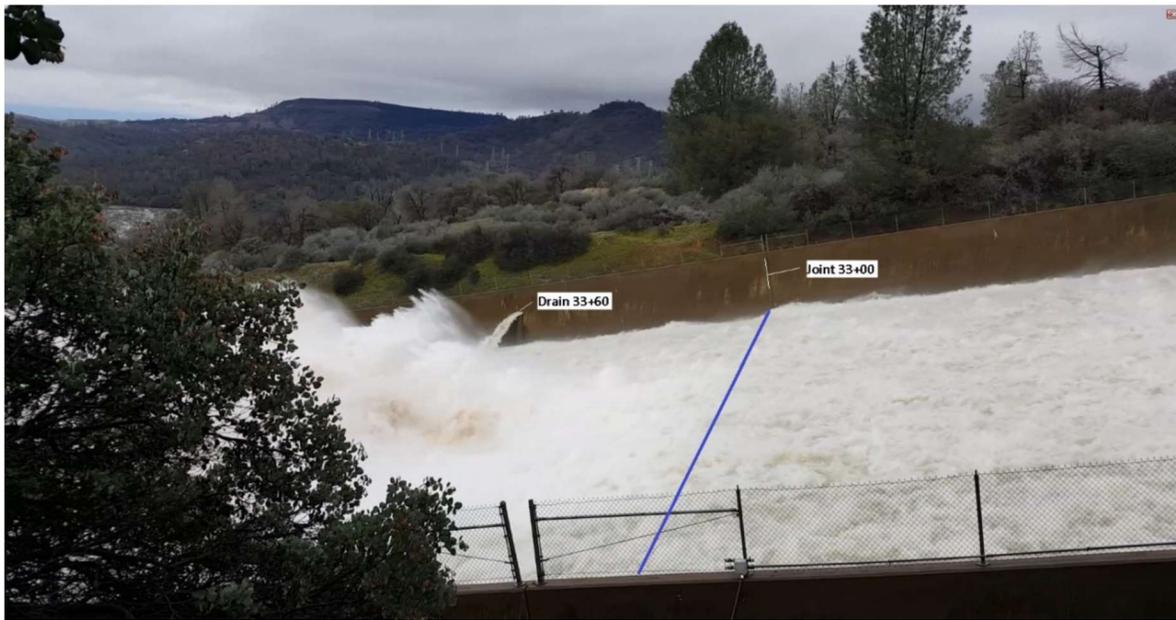
**Fig. 2.3.2 Water Splashing against Offset Downstream from Sta. 33+00**

The stagnation pressure of the high velocity shooting flow against this offset (a high proportion of the velocity head), propagated under the slab through vertical cracks and/or joints, producing a large uplift force that raised and dislodged part of the slab. The high stagnation pressure produced a water-splashing phenomenon captured in photos by an operator as shown in Fig. 2.3.2. The earliest photos were probably taken after the initial removal of a portion of the slab. The splashing effects were probably too small to be noticed in the early stages but became clearly visible as the slab removal process developed and the resulting offset into the flow increased.

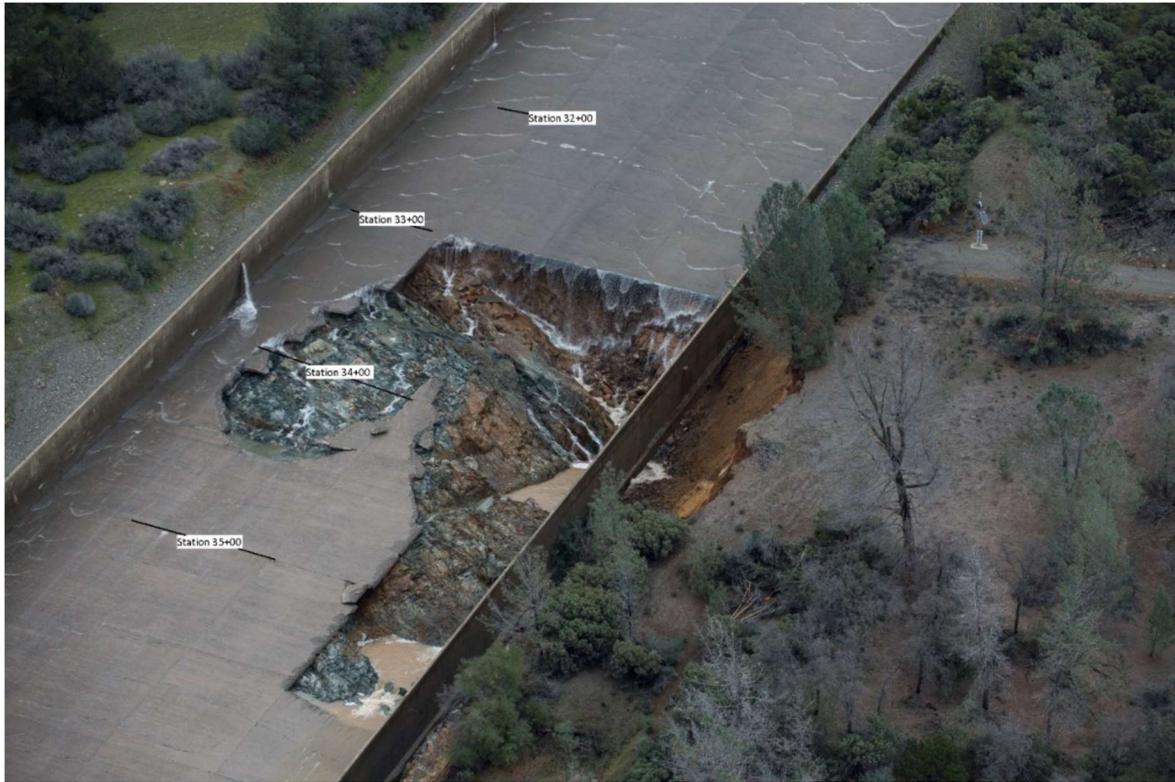
**Fig. 2.3.3 Initial Erosion Visible on February 8, 2017**

The removal of the slab sections further downstream was a natural domino effect, typical of chute spillway failures, which had been common in the early days of poor anchoring and inadequate slab drainage provisions in chute spillways. The extensive rock erosion that followed and progressed mostly downstream, and to a lesser degree upstream, were natural effects from the fast and turbulent water flow over the weak and unlined rock chute, Fig. 2.3.3.

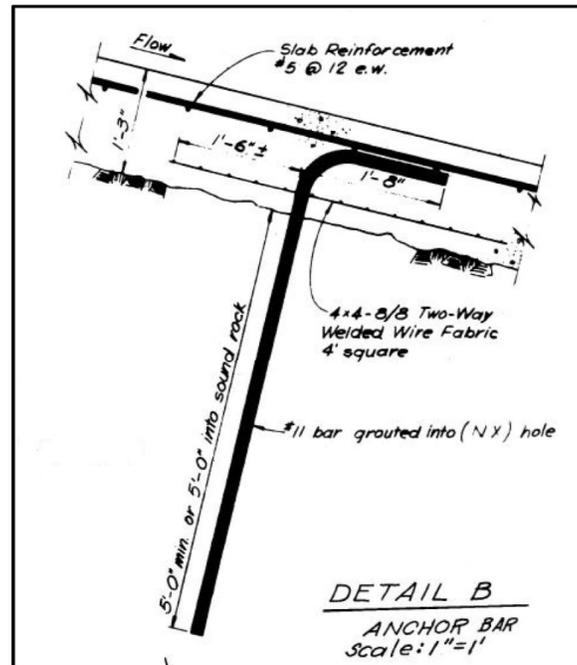
**Fig. 2.5.1 (IFT, p. 14)**

Figure 3-7: Typical anchor bar installation [5]

It is important to note that the dimension shown for the anchor bar length in Fig. 2.5.1 specifically indicates that the anchor bar should extend a minimum of 5 ft. from the top of the rock or 5 ft. into sound rock. This was clearly ignored, or violated, in the area of the failure where anchors were drilled into weathered rock / soil like material where the design capacity was severely compromised.

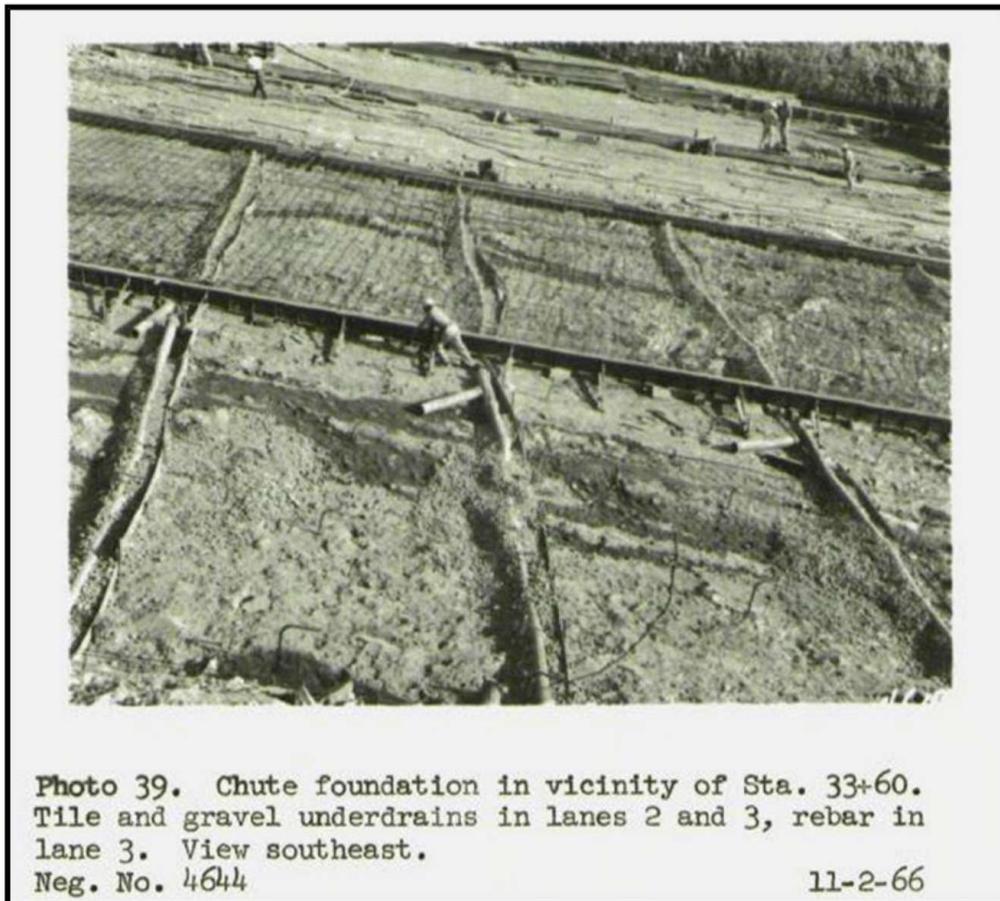
**Fig. 2.5.2 (IFT, p. 17)**

A comprehensive geological mapping of the excavated spillway alignment was carried out during construction to assess the depth of the chute foundations, and its findings are documented in the “as built”, 1970 Geological Map of the Spillway Foundations. A review of this mapping, DSOD memorandums, and other information indicates that the chute slab foundations in the flat section of the chute, from the FCO structure to Sta. 29+00, were placed on hard, irregular surfaces with a variable thickness of the chute slab. Isolated pockets, of highly weathered rock were left at some location along the chute, i.e. ~Sta. 20+00. However, in an area just upstream of Sta. 33+00, in the inclined portion of the chute, a 75 ft wide zone of steeply inclined, highly weathered shears intersecting the alignment were encountered. The depth of the highly weathered rock was reported to be about 60 to 75 ft on the geology map of the spillway foundations. Although the foundations in this area were judged (by DSOD) to be the “softest in the whole chute” the excavation and clean up extended only 1 to 2 ft below design grade and the slab was placed on clayey materials. The chute anchors were embedded 5 ft. within the soft materials, not 5 ft. into sound rock as specified in the design and shown on Fig. 2.5.1. This modification is considered significant and this led to the foundation condition shown

in Fig. 2.5.2 at Sta. 33+60 on Nov. 2, 1966, where extensive areas of soil like materials are shown in the foundation.

**Figure 3-11: Lane 3 downstream from Sta. 33+00 being prepared for placement. [9]**  
**Note what appears to be extensive areas of soil-like materials in the foundation.**

- 1) The deep erodible soil material left in place just downstream of Sta. 33+00, as shown in Fig. 2.5.2 in November 1966;
- 2) The installation of 5 ft. long anchorage in this area was clearly inadequate; and
- 3) The geometry and size of the herringbone drains were changed by the Board in April 1966 reducing the thickness of the slab.

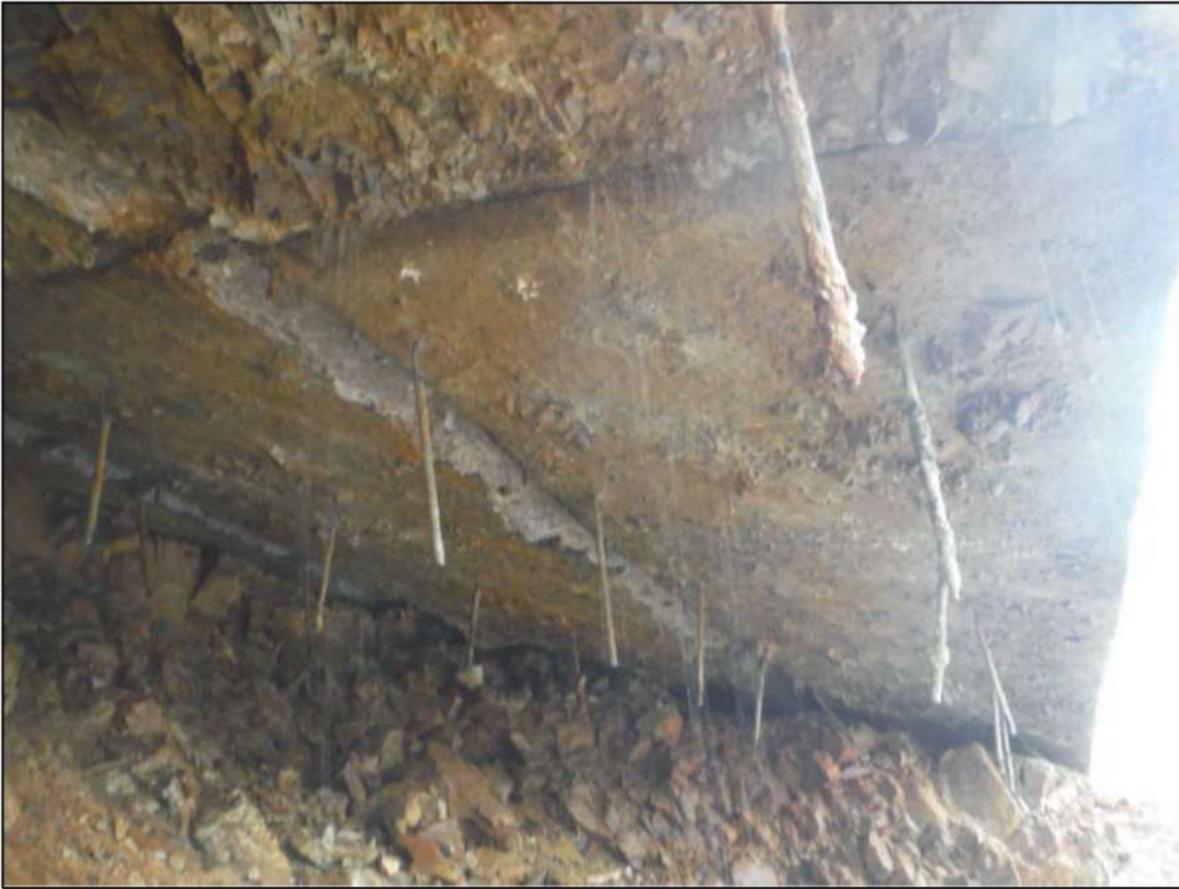
**Fig. 2.5.3 (IFT, p. A-27)**

The presence of the soil-like materials within the foundations and lack of anchors being extended 5 ft. into sound rock resulted in the poor performance of the as constructed chute slab foundation/anchor system shown in Fig. 2.5.3.

**Figure A-19: Anchor bars on the underside of the slab upstream of Sta. 33+00 (on right edge). Note the smooth underside of the chute slab that was to have been placed on a rock foundation which would have been expected to be irregular. (Photo DSCF9788)**
